Annele Matintupa, Seppo Tuisku

SUMMARY OF DRAINAGE ANALYSIS IN THE WESTERN ISLES, SCOTLAND

Demonstration Project Report

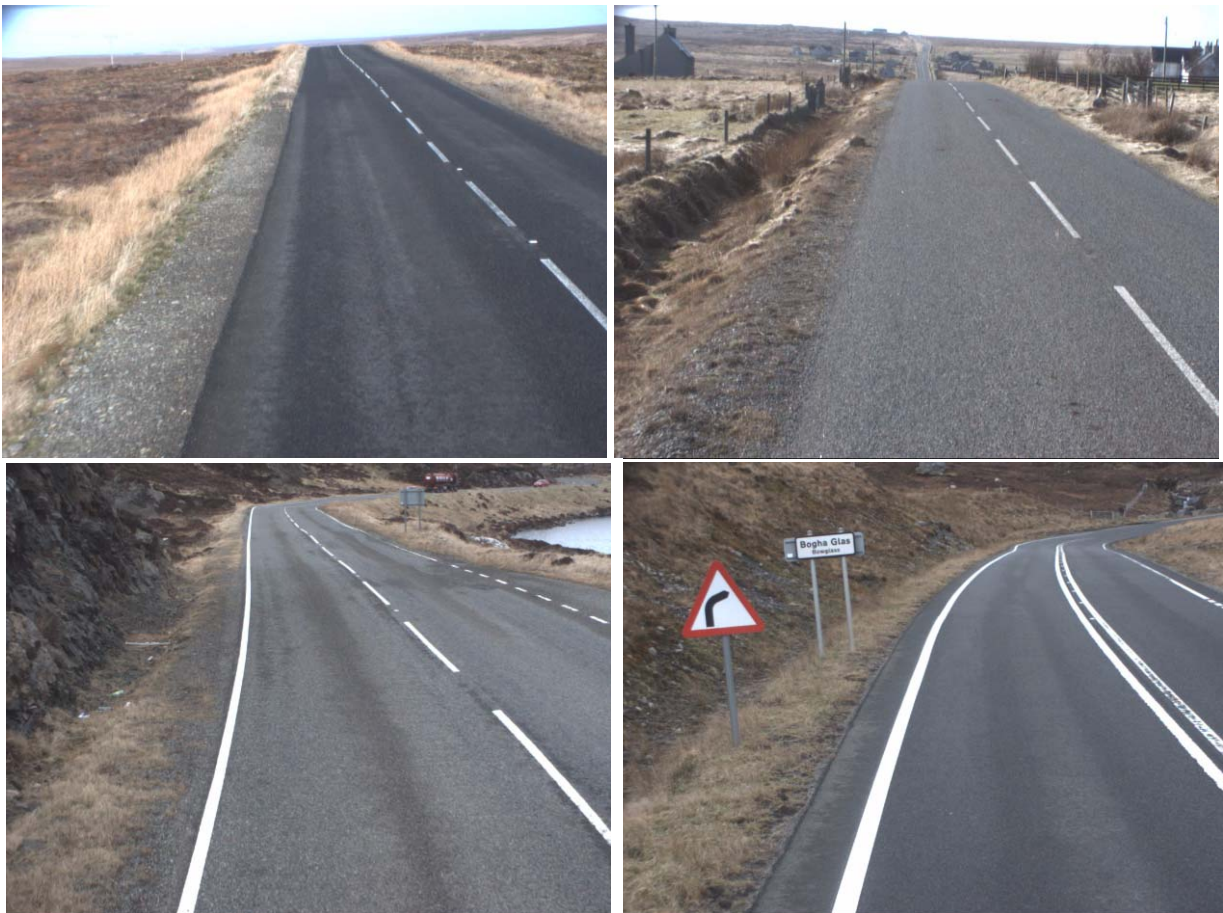
Drainage Class 1 means that the drainage condition is faultless. The cross-section of the road has preserved its form well and water flows unrestricted from the pavement to the ditch. Water has also a clear passage in the ditches. Where a verge is present it has enough offlets to let the water flow to the ditch.

Figures 29: Examples of road sections with drainage Class 1 in the Western Isles

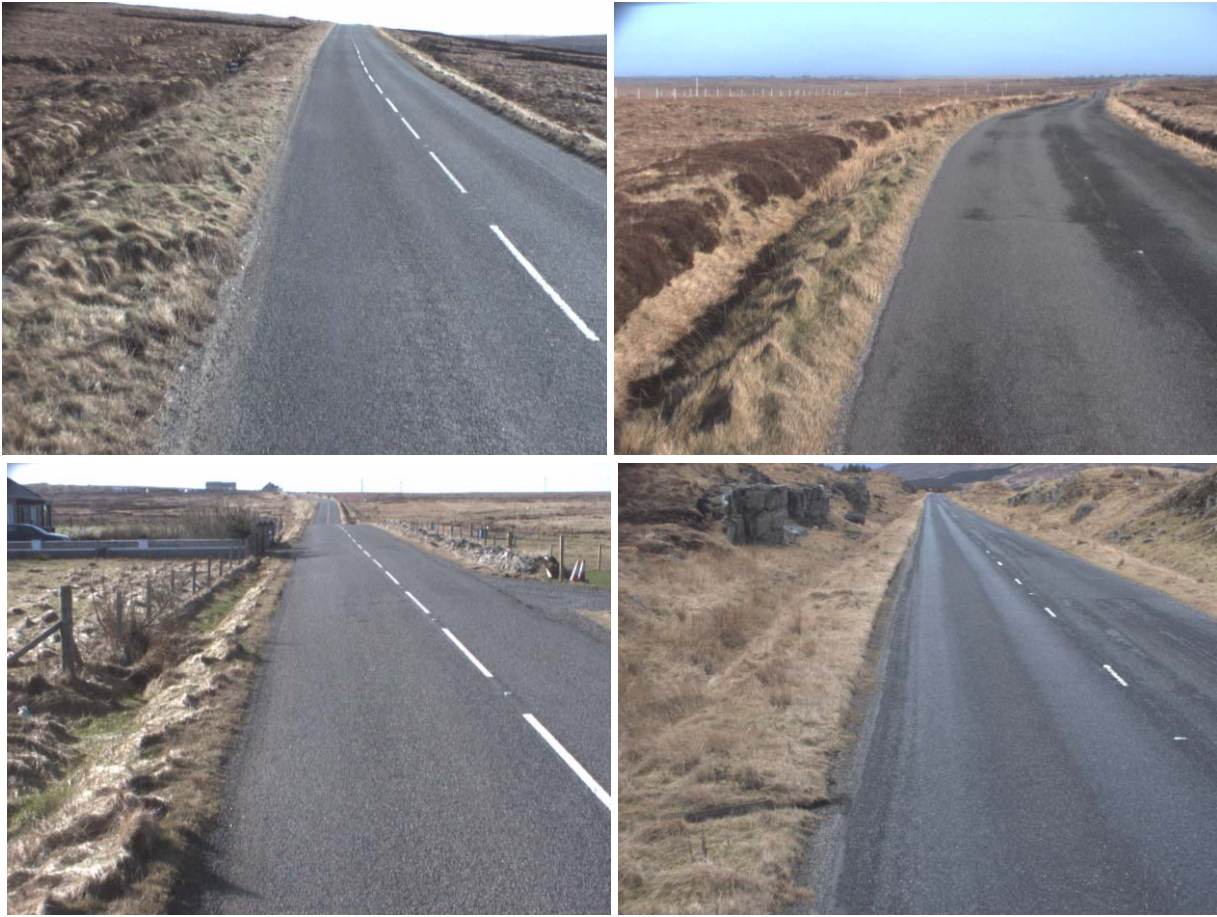
In drainage Class 2 there can be some visible changes to the road cross-section. The road shoulder has narrow verges or vegetation growth that is preventing the free flow of surface water from the road surface into the ditch. There is some vegetation in the ditch that restricts water flow and creates damages. Some soil is sliding from the road side slope into the ditches and raising the bottom of the ditch. This hinders water flow and raises the ground water level.

Figures 30: Examples of road sections with drainage Class 2 in the Western Isles.

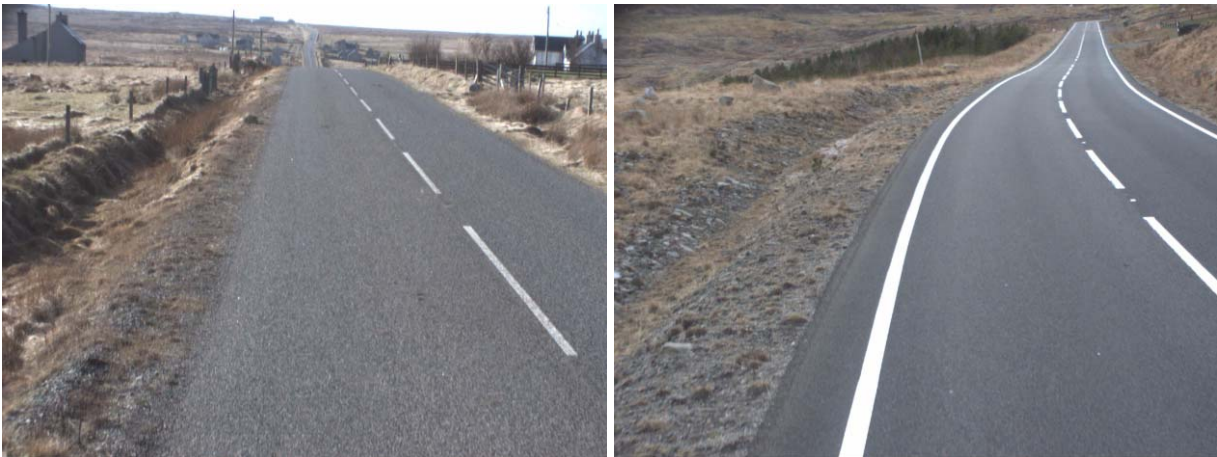
Class 1 verges cover those road sections where there is no verge and water can flow freely from road surface. Figure 33 presents two examples of verge Class 1 road sections.

Figure 32: Two examples of verge Class 1, i.e. road sections without verges.

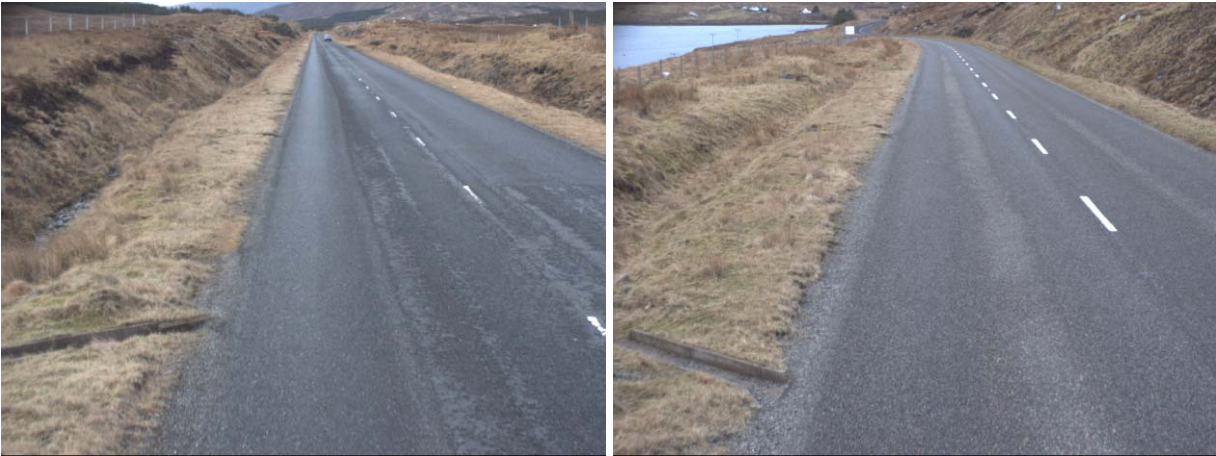
Class 2 verges cover all road sections with minor verges and adequate offlets. The number of offlets is enough to ensure proper drainage and they are in good condition. The water can flow freely from the road surface. Verges do not restrict the water flow or the workings of the road drainage system. Figure 33 shows a few examples of road sections with verge Class 2.

Figure 33: Two examples of verge Class 2, roads with a verge which has minor effect on the workings of the road drainage system.

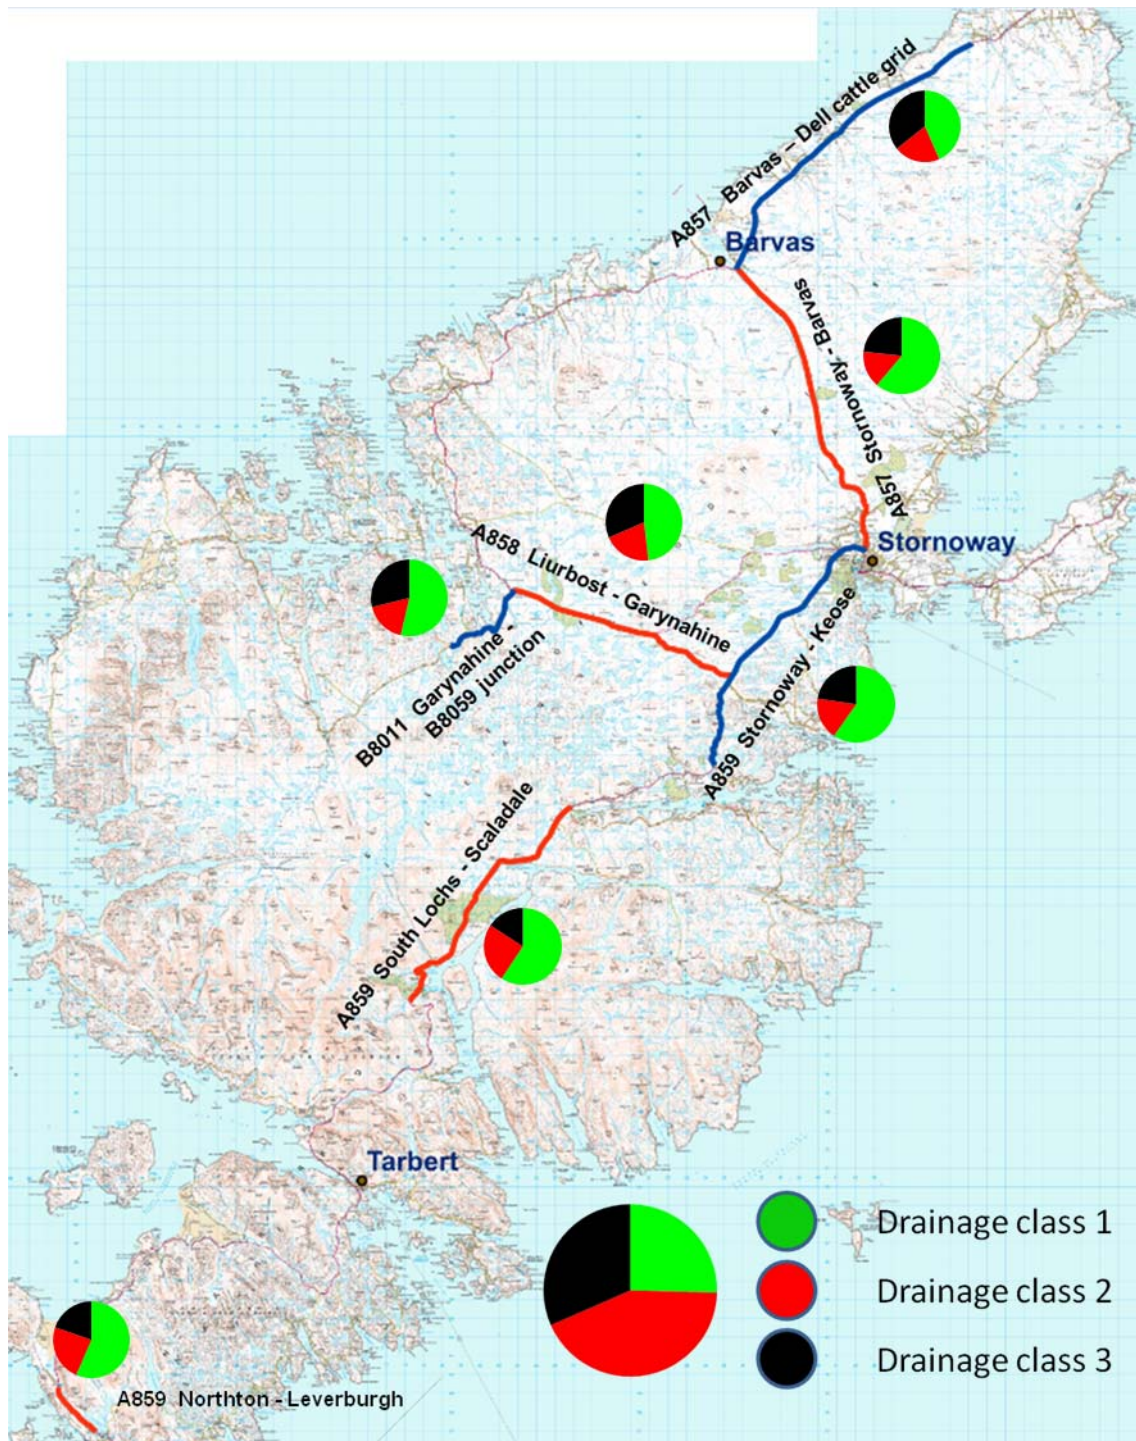
The drainage and verge classes of each section were examined statistically. The distribution of average drainage classes in each surveyed section is presented in Figure 39. The worst sections for drainage class from a statistical point of view were the A857 section from Barvas to Dell and the A859 section from Stornoway to Keose.

Figure 39: Distribution of average drainage classes in the surveyed roads

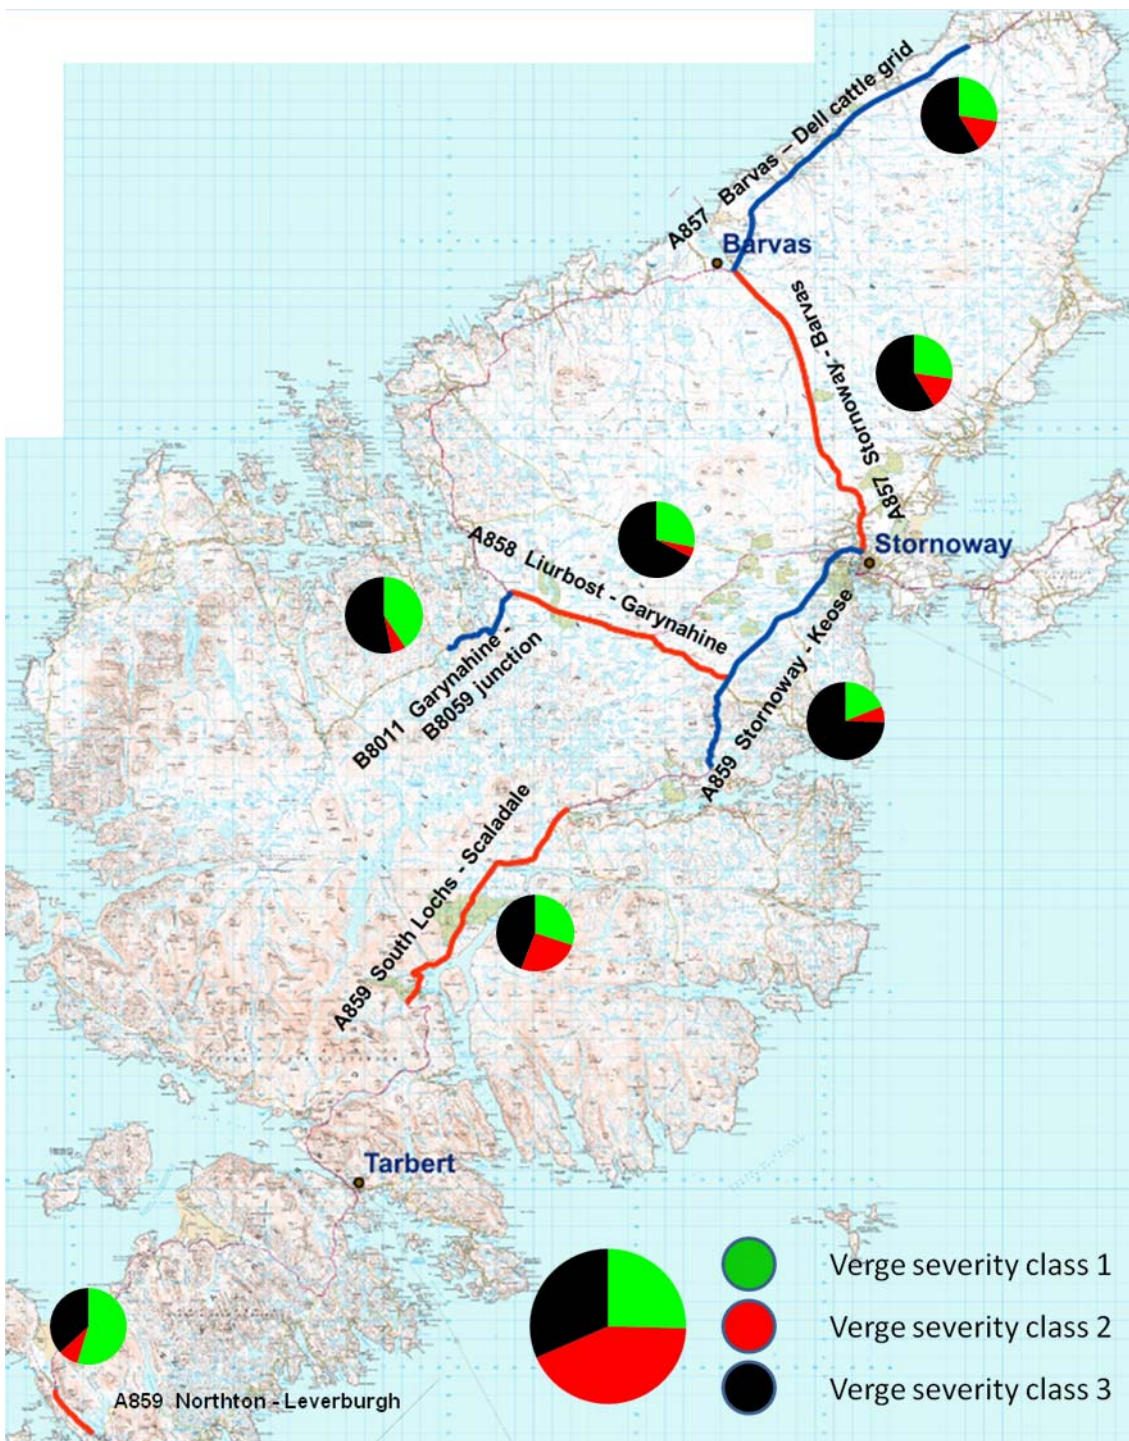
The distribution of average verge classes in each surveyed section is presented in Figure 40. The sections with the highest percentage of verge Class 3 were the A859 section from Stornoway to Keose and the A858 section from Cameron Terrace to Garrynahine. The best section for verge classification was the A859 section from Northton to Leverburgh.

Figure 40: Distribution of verge severity in the surveyed roads

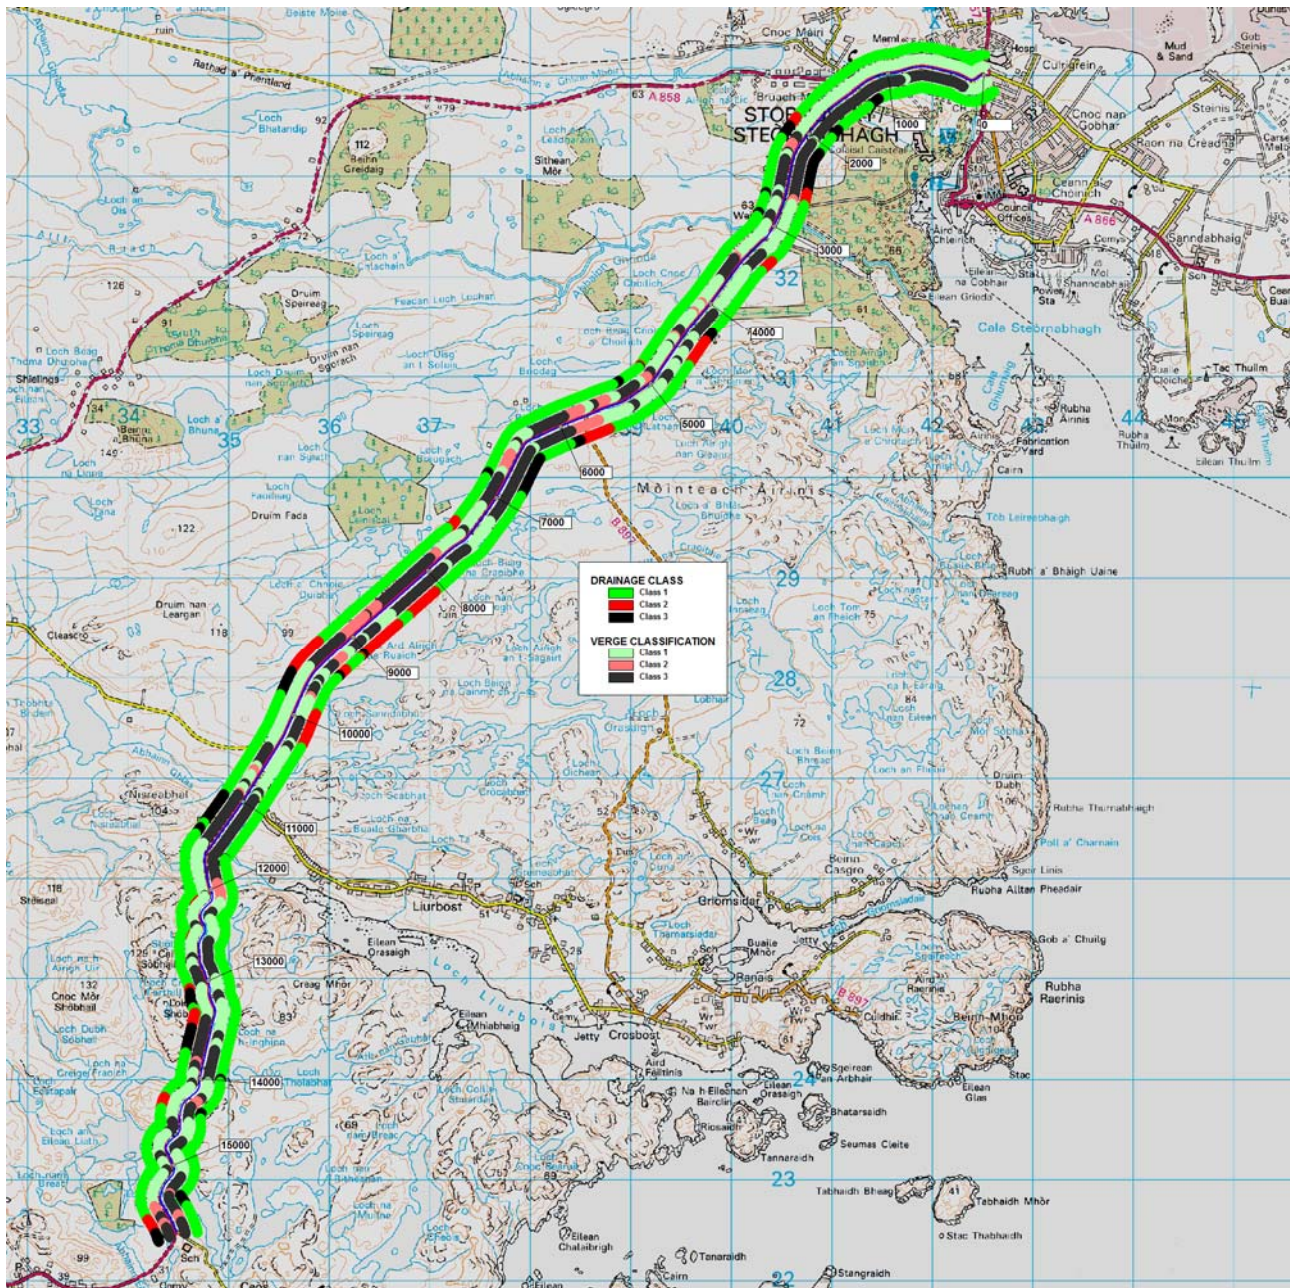
The detailed statistical maps for each road section surveyed are presented in Figures 41-47. These maps are printed from Road Doctor project trees to show the drainage and verge classification of each section. From these detailed maps it can be seen that in many cases where severe verge problems were observed there were also problems with the ditches.

Figure 41: Drainage and Verge classification in road A859, section Stornoway – Keose

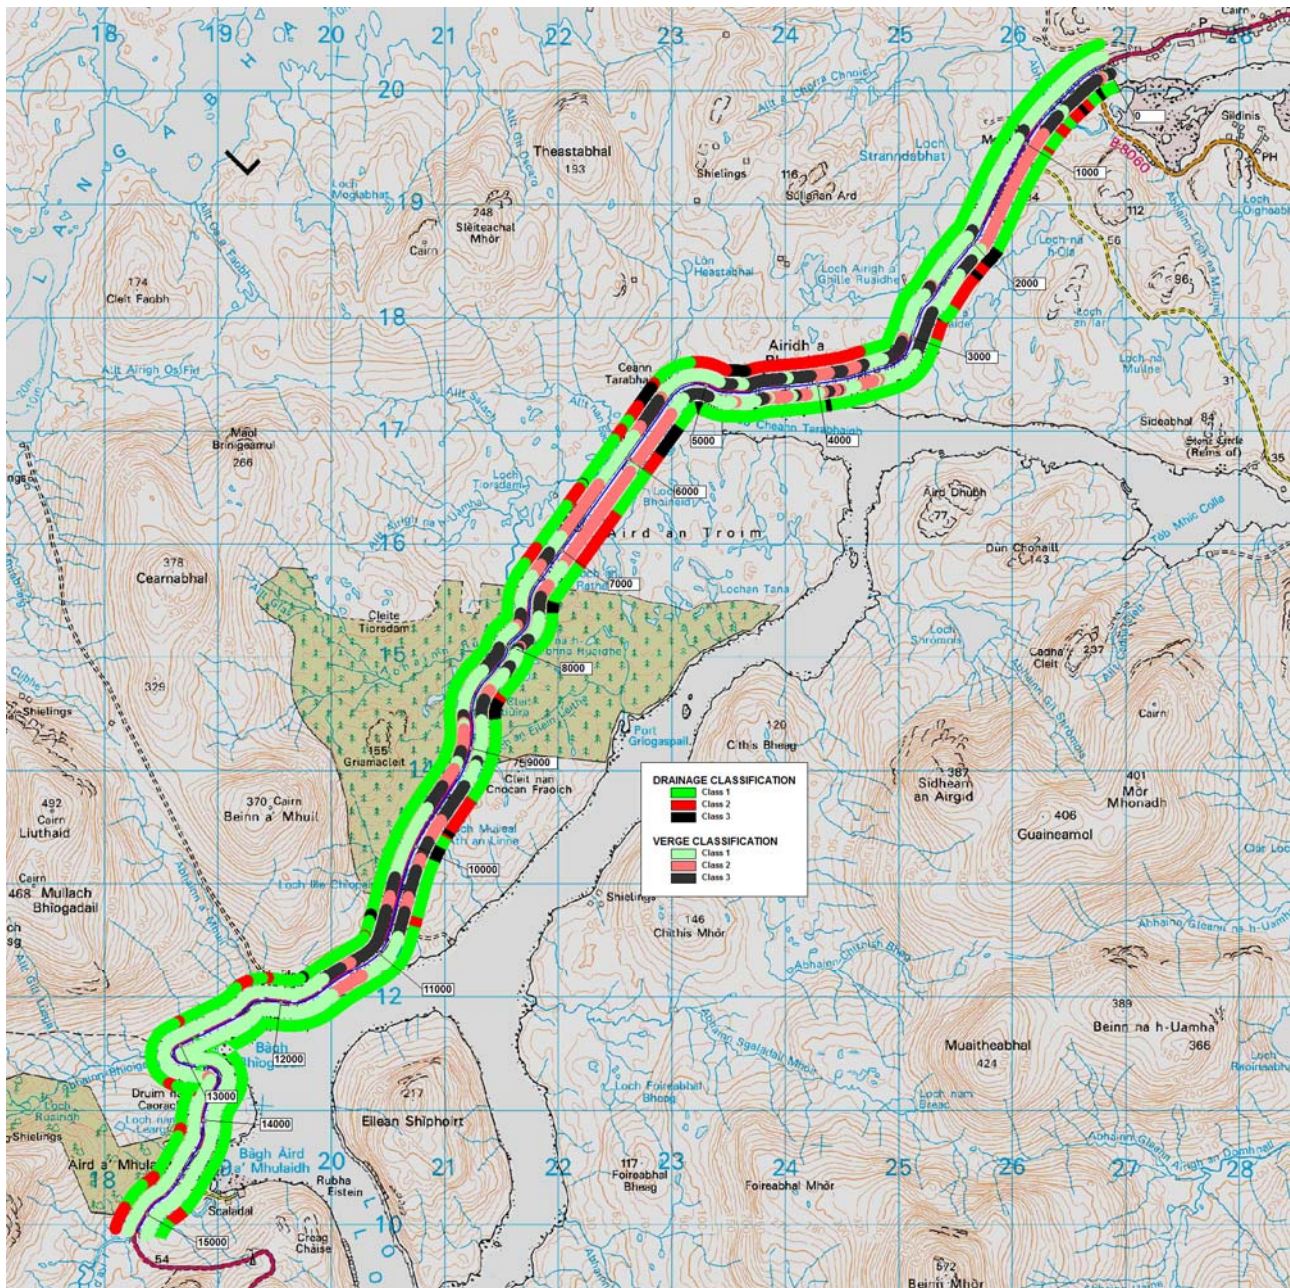
Figure 42: Drainage and Verge classification in road A859, section B8059 – Scaladale

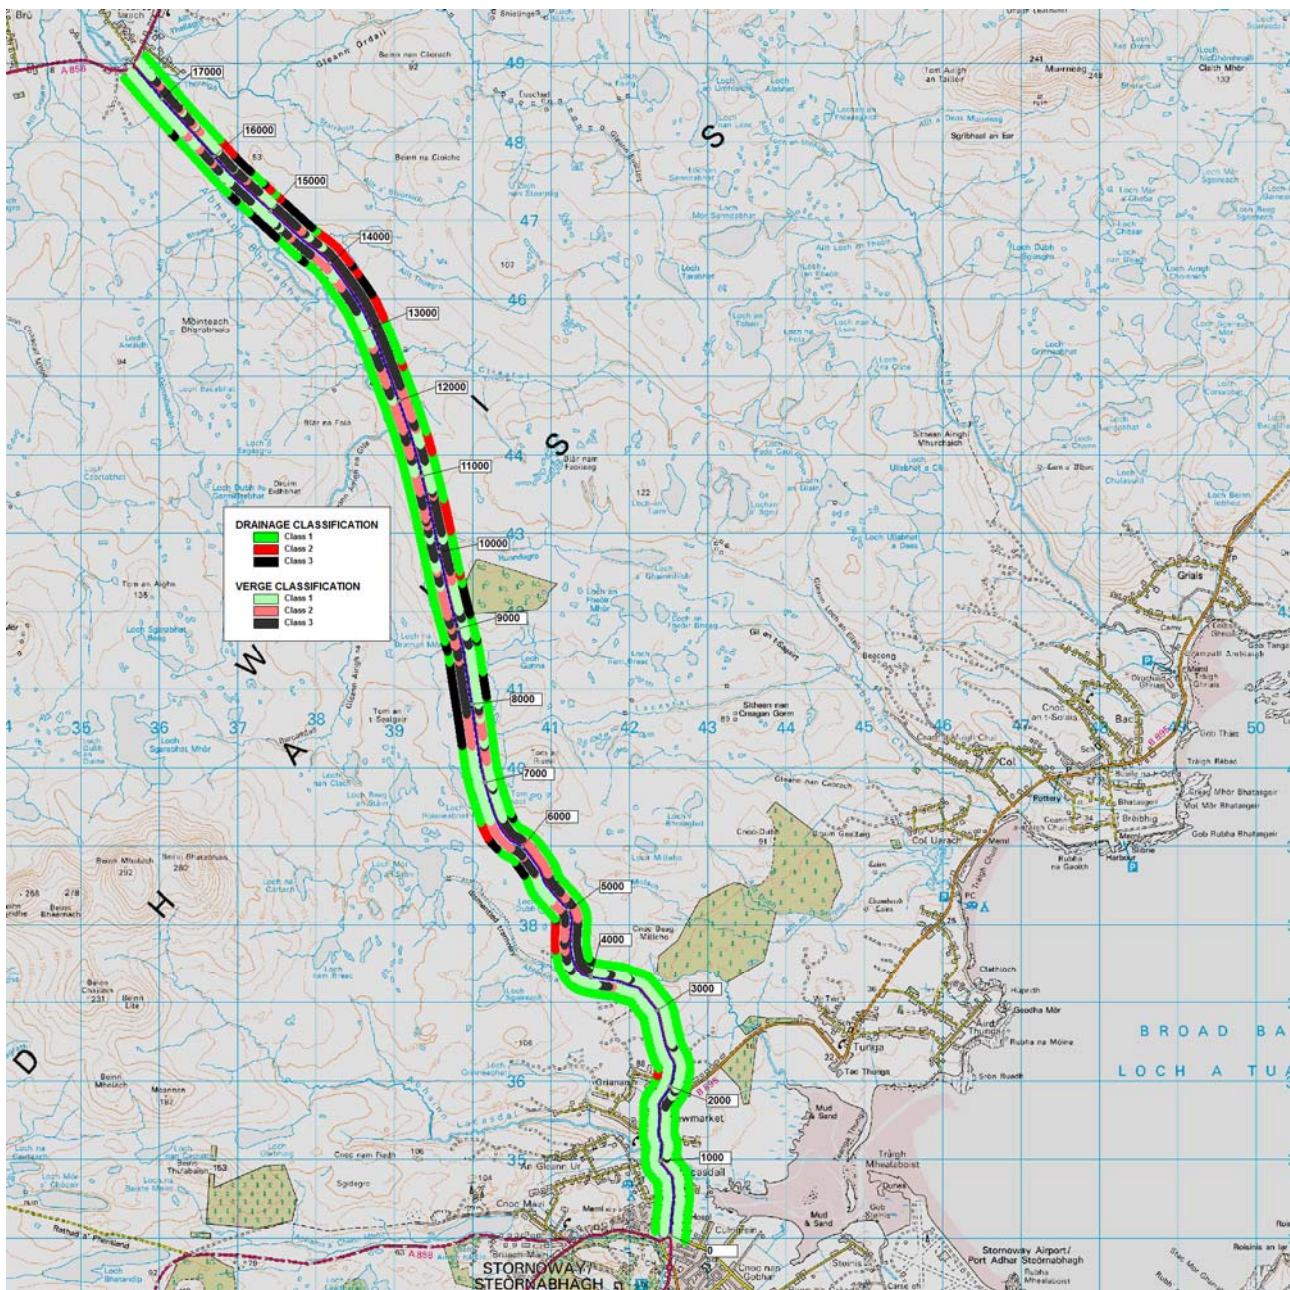
Figure 44: Drainage and Verge classification in road A857, section Stornoway – Barvas

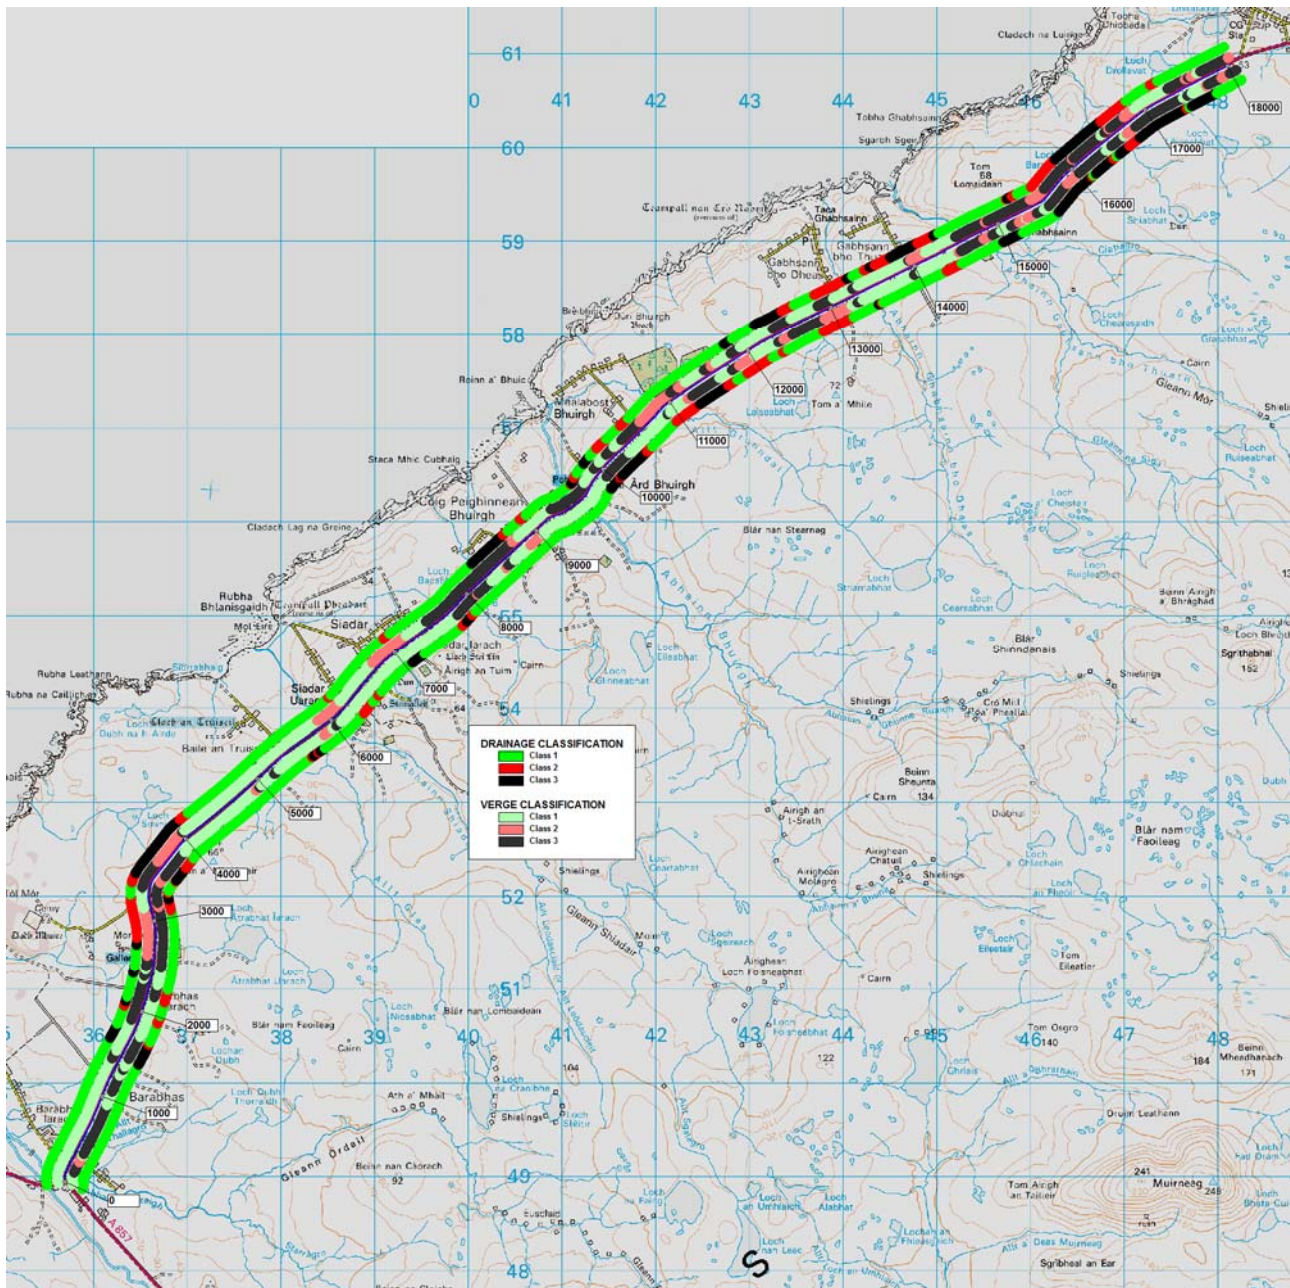
From Loch Barabhat to the end of the section at Dell cattle grid there was a long section with inadequate drainage. The section was located on peat and the road profile was mostly in side sloping ground. The most of the road damage was on the upper side of the side slope.

Figure 45: Drainage and Verge classification in road A857, section Barvas – Dell

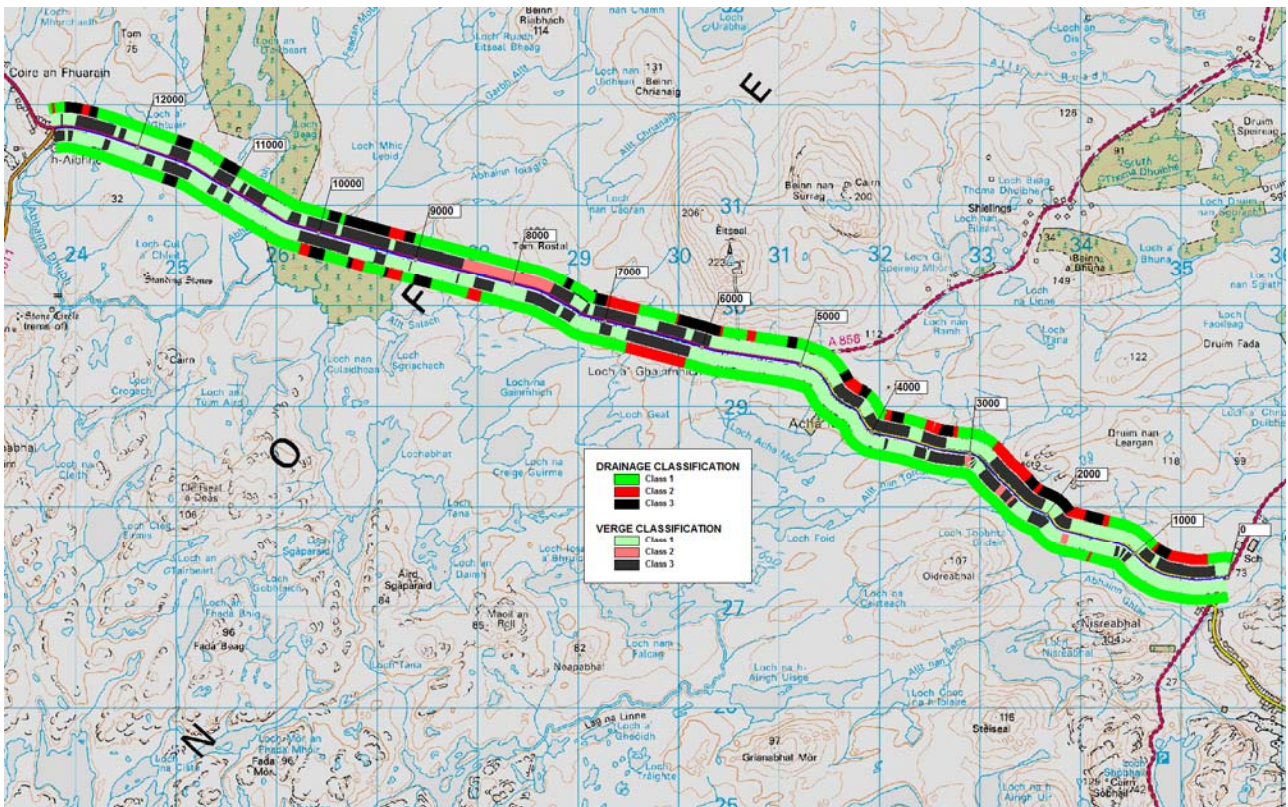
Figure 46: Drainage and Verge classification in road A858, section A859 – Garynahine

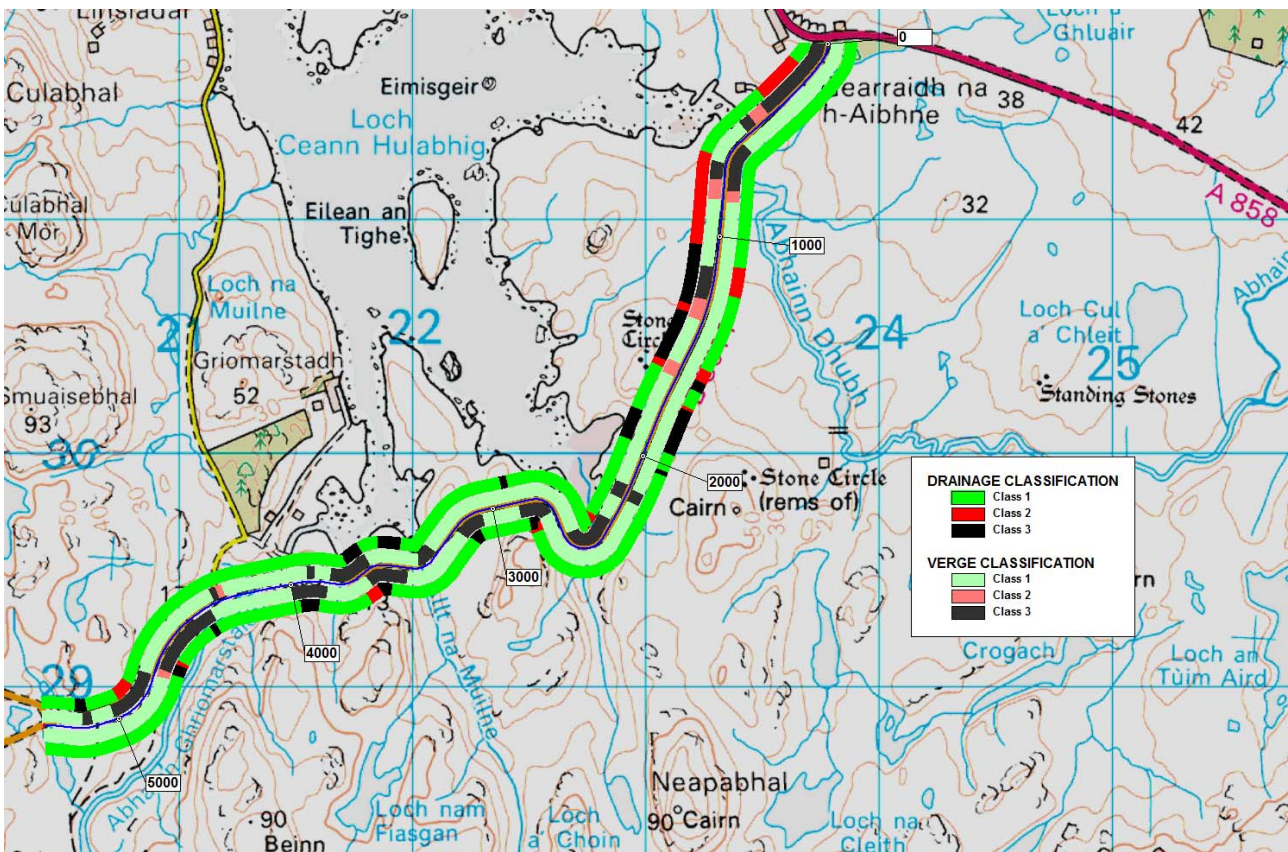
Figure 47: Drainage and Verge classification in road B8011, section Garynahine – B8059

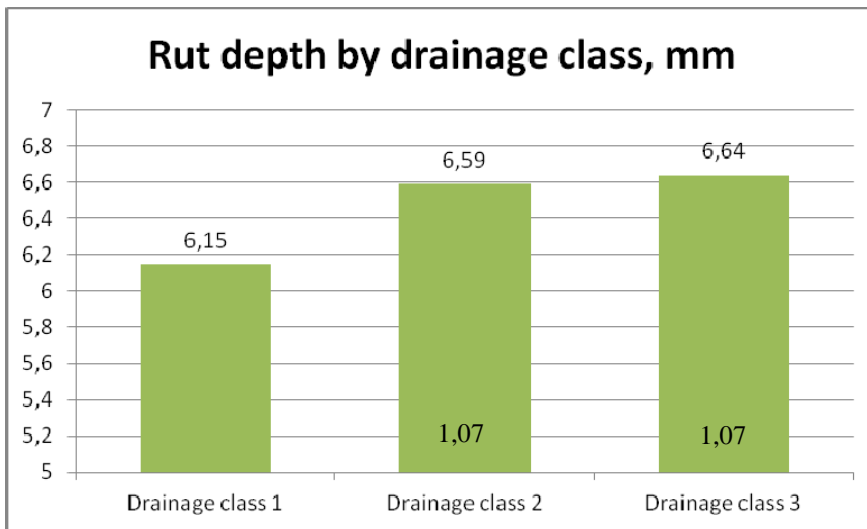
Figure 49: The average rut depth value for each drainage class. The value on the top of the column shows the average rut depth value on each drainage class. The factor inside the column shows how many times bigger the value is compared to the value for Class 1.

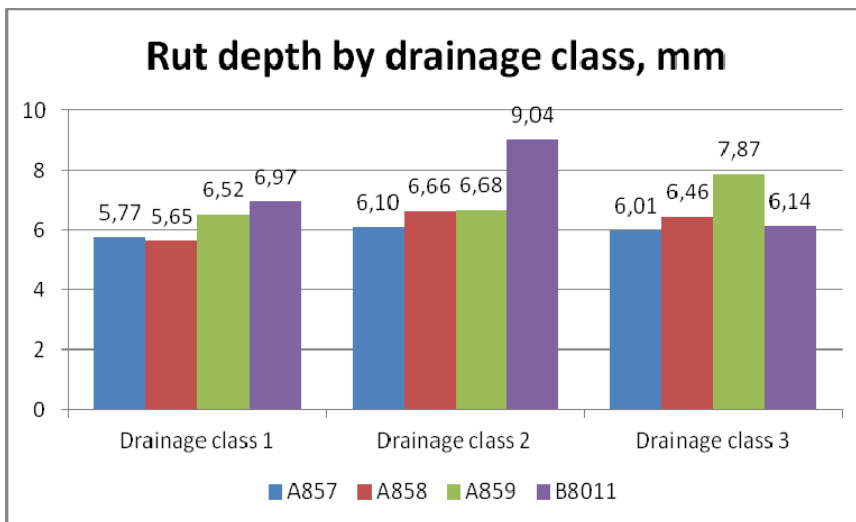
Figure 50: The mean rut depth values classified by drainage classes in surveyed roads.

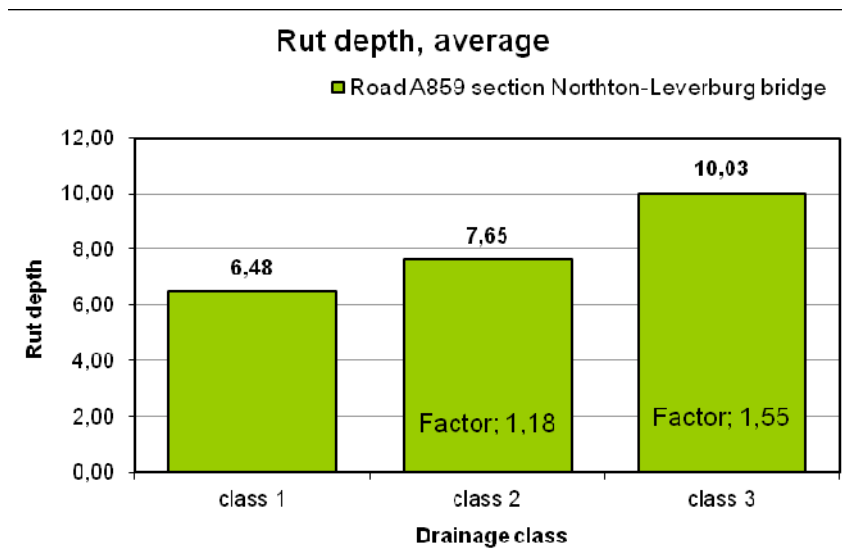
In the surveyed sections there was one section where the side slope happened to be the “opposite way” compared to normal rutting data collection. This section was on the A859 from Northton to Leverburgh Bridge. Nearly all this section was in side sloping profile and the upper side of the slope was on the left side of the road which was the lane where rutting data was measured. In this section the correlation between the drainage classification and rutting was much stronger than the average. On the other hand there was no correlation between verge class and rutting values in the section. (Figures 50 and 51).

Figure 51: Rut depth classified by drainage classes in road A859, section Northton – Leverburgh Bridge. The factor inside the column shows how many times bigger the value is compared to the value for Class 1.

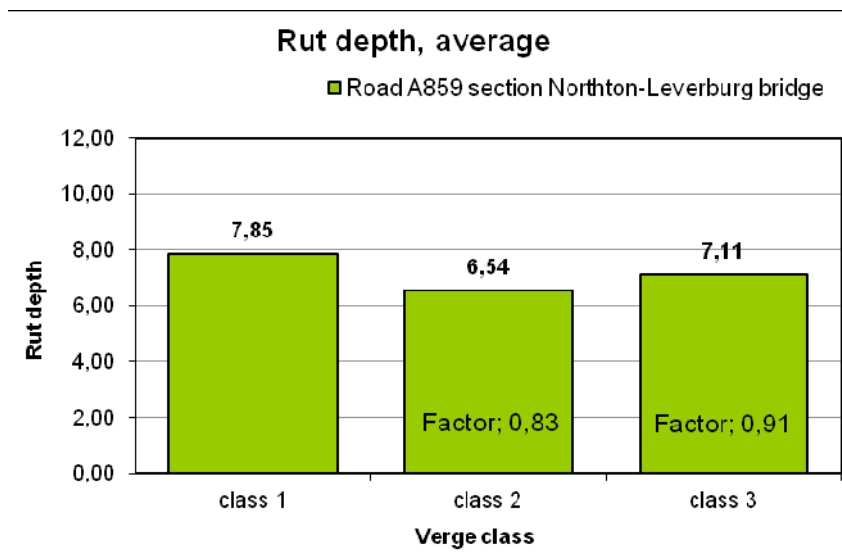
Figure 52: Rut depth classified by verge classes in road A859, section Northton – Leverburgh Bridge. The factor inside the column shows how many times bigger the value is compared to the value for Class 1.

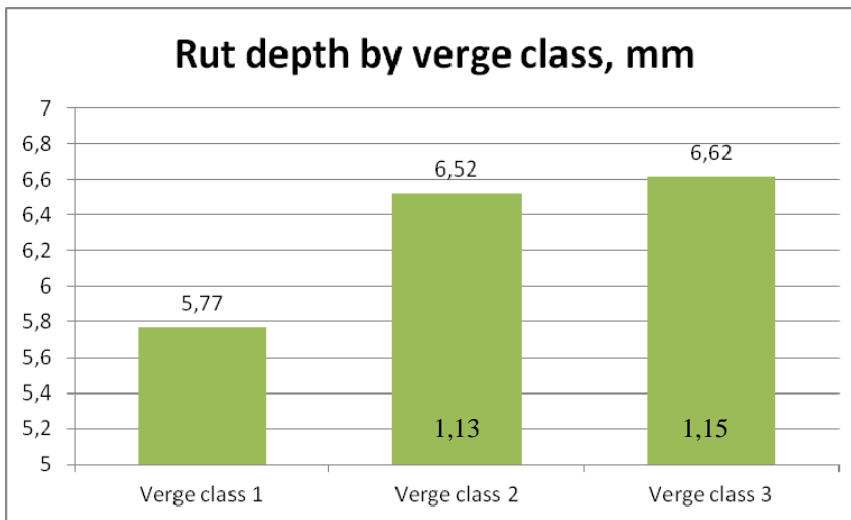
Verges also have an effect on the roughness and rutting of a road. In this project it was not possible to examine the affect of the verges on roughness as data on roughness was not available. Overall, for the particular circumstances of the Western Isles, it appears that the presence of roadside verges has even a bigger affect on rutting values compared to drainage problems. It was noted that there were cables inside the verges in some locations. Lowering or removing these verges could be difficult and expensive.

Figure 53: The average rutting value compared to verge classes. The value on the top of the column shows the average rutting value in each drainage class. The factor inside the column shows how many times bigger the value is compared to the value for Class 1.

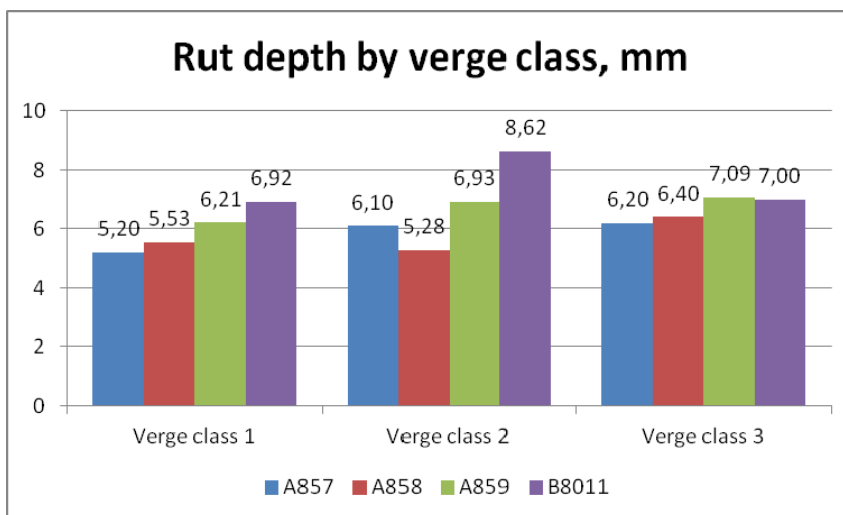
Figure 54: The mean rut depth values classified by verge classes in surveyed roads.

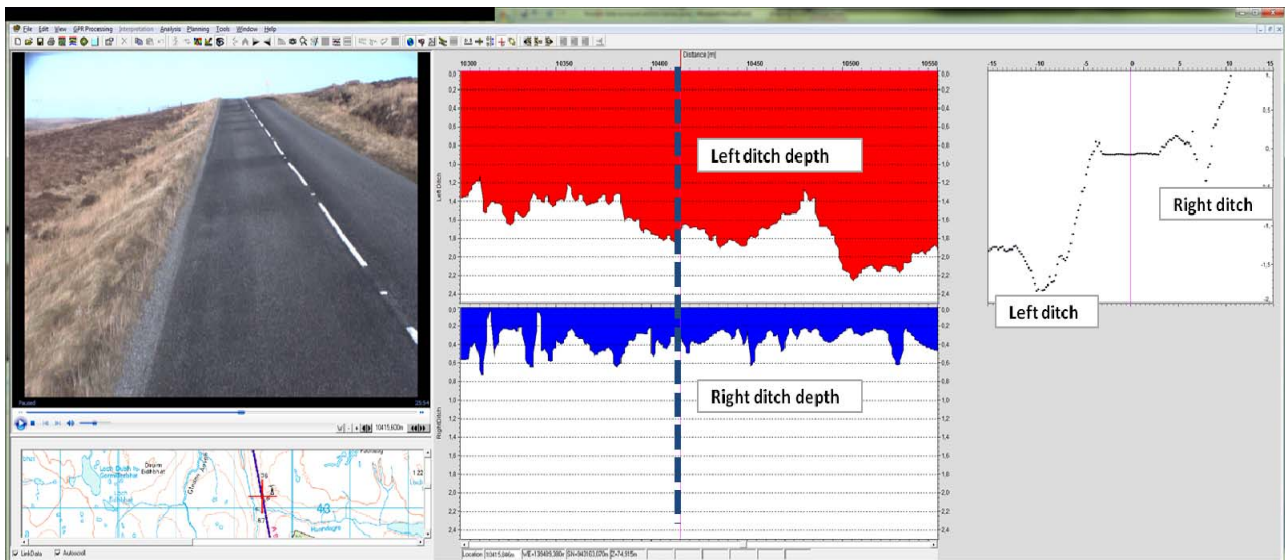
Figure 56 and 57 show examples of the analysis of ditch depths using the data from laser scanner surveys. The depth of the ditch is calculated from the difference in level between the road centreline and the bottom of the ditch. As already mentioned the verges and the vegetation in the ditches can affect the accuracy of the data laser scanner data.

Figure 56: Example of the data view where the road profile is in side sloping ground from right to left. The top panel shows a profile of the left ditch depth from 10300 to 10550, and the bottom panel shows the depth of the right ditch over the same distance. The blue dashed line indicates the position of the cross section. It will be seen that the right ditch is very shallow over this length..

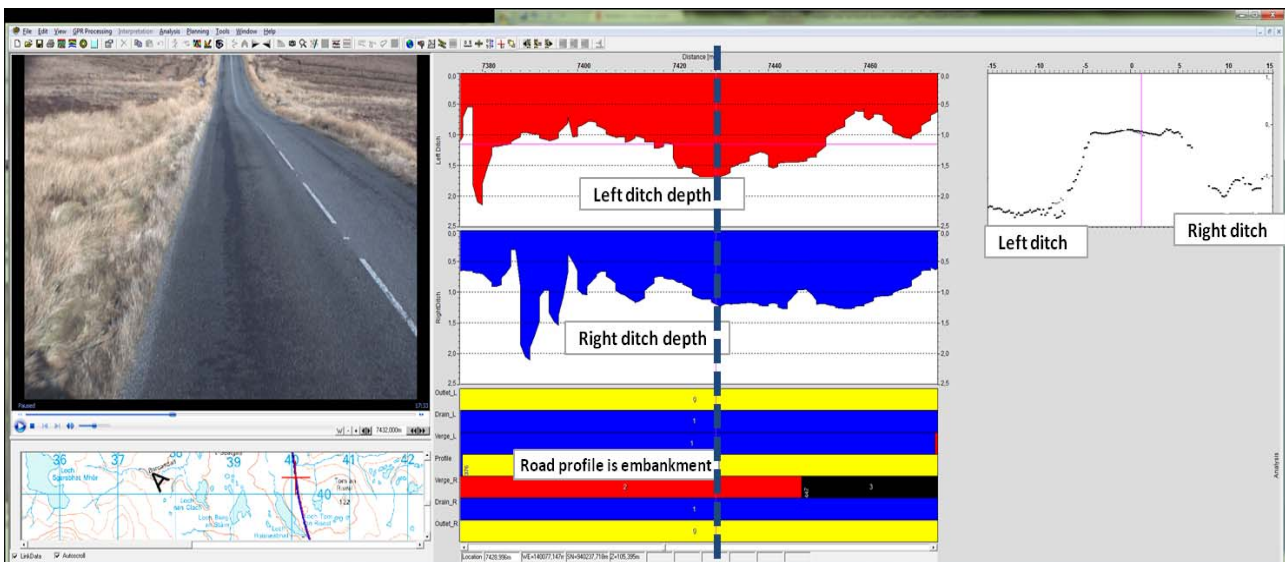
Figure 57: Example of a section in embankment. There are no real ditches on this section but the program sees the toe of the embankment as the depth of the ditch.

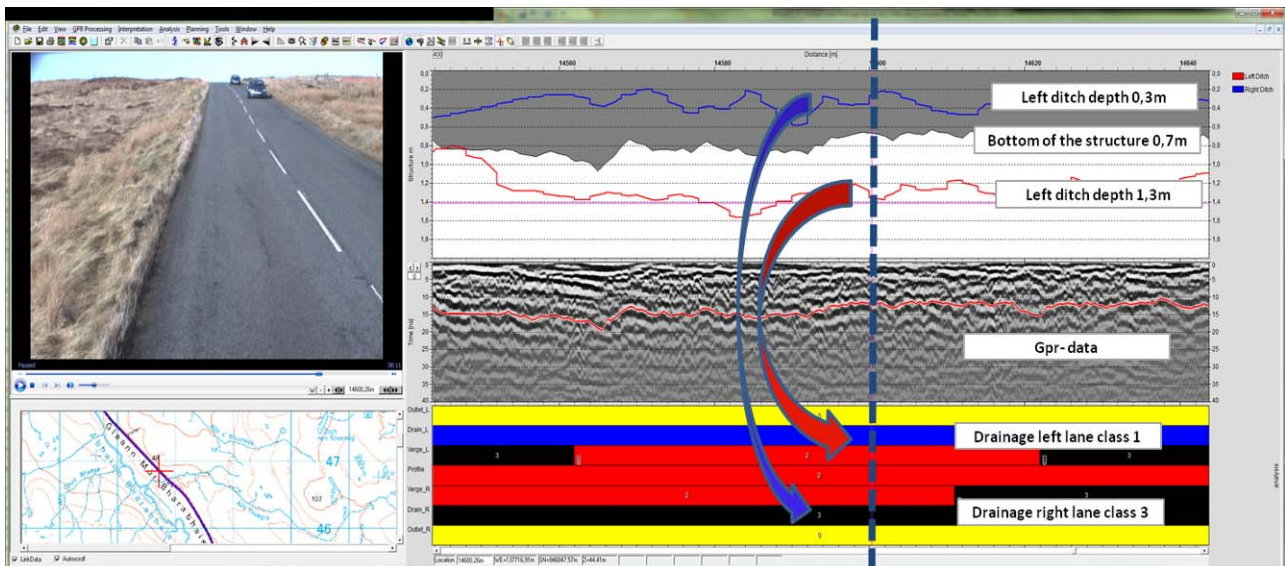
order to demonstrate the calculation this GPR data was linked to the drainage analysis survey so that the project road structure thickness could be interpreted. When this was done an example was prepared to show what the results would have been if it had been possible to combine the GPR and laser scanner surveys (Figure 58). This example taken is from the A857 Stornoway to Barvas section at chainage 14600m. The road profile is side sloping and on the right side the drainage is Class 3. The ditch is shallow and full of vegetation. The grey panel in the screendump is the bottom of the road structure interpreted from the GPR data and the coloured lines are the ditch depths from the laser scanner data. From this figure it can be clearly seen that the bottom level of left ditch is too high and water is flowing from the ditch to the road structure causing failures. In this case the left ditch should be excavated deeper.

Figure 58: An example of the integrated analysis of GPR data and laser scanner information in drainage analysis. The data is from A857 Stornoway - Barvas.
