Annele Matintupa, Seppo Tuisku

SUMMARY OF DRAINAGE ANALYSIS IN THE WESTERN ISLES, SCOTLAND

Demonstration Project Report

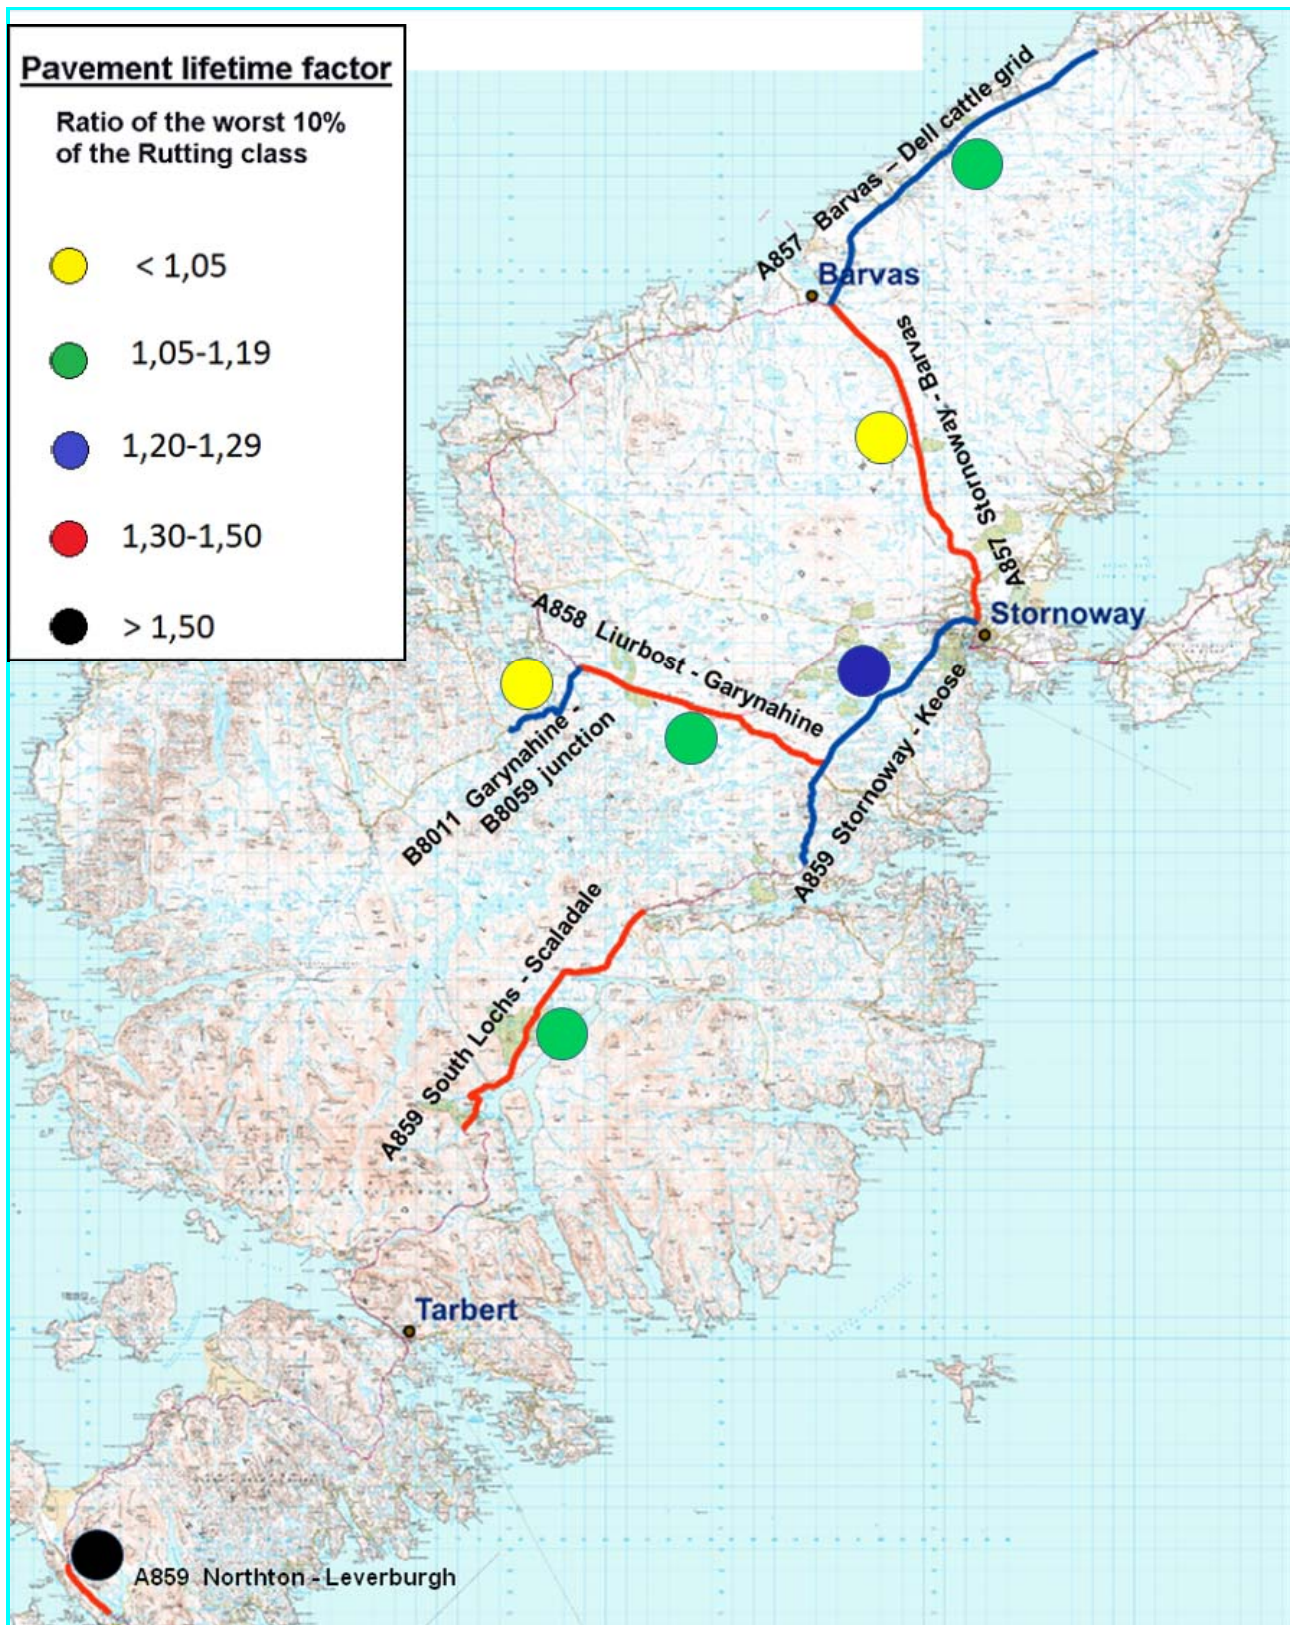
Figure 61 shows the results of pavement lifetime factor calculations (the ratio of the worst 10% rutting class) for the roads surveyed in the Western Isles. These factors varied from <1.5 for road A859 to >1.5 for the Northon to Leverburgh road. The other roads (A857, A858 and B8011) appear to have better lifetime factors, even when their drainage is worse than A859, but this can probably be explained by the rut depth survey lane as explained earlier.

Figure 63: Pavement lifetime factor for the roads surveyed in the Western Isles
