Poor road condition as a health risk

Johan Granlund, Chief Technology Officer
Vectura Consulting AB, Sweden

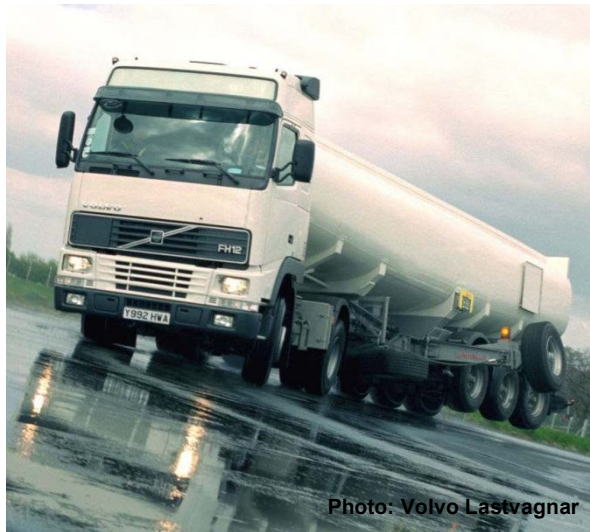
Heavy vehicles are extra susceptible to lateral forces

The crash type were most truck drivers are injured is the rollover. A high C.O.G. makes the heavy vehicle prone to improperly banked outercurves.

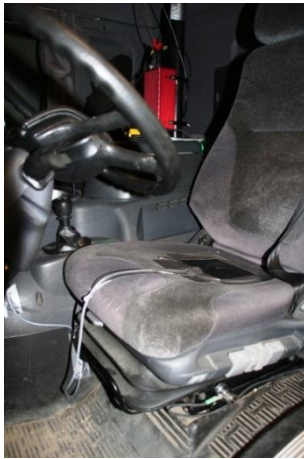
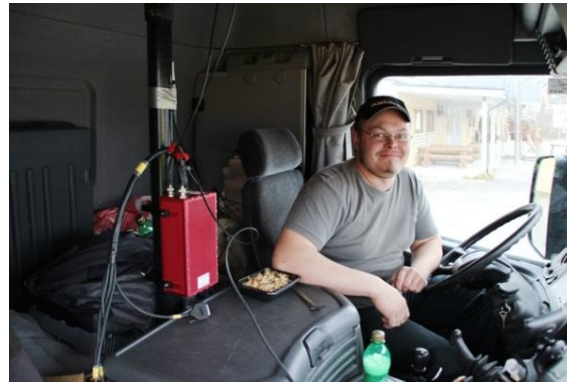
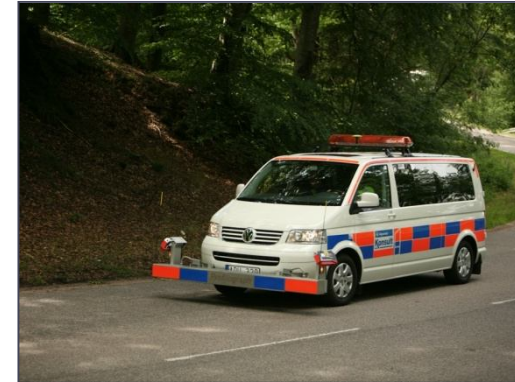
Roadex demonstration projects in Finland, Scotland, Norway and Sweden

Demonstrating the ROADEX method for recording vibration in drivers and reconciling the data collected with road condition measured by profilometer.

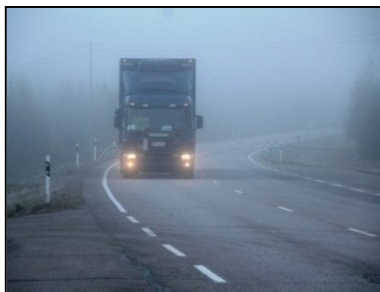
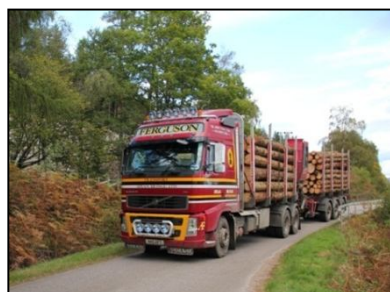
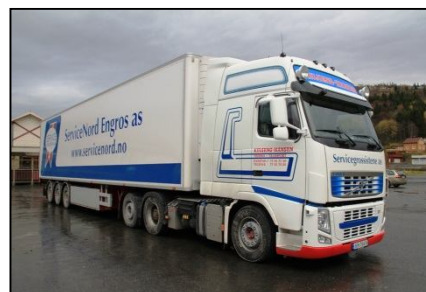
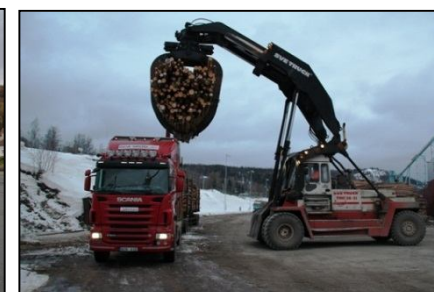
3700 km demo. measurement

Partner	Location	Vehicle
Lapland	Hw 21 Pello – Kilpisjarvi. Raattamaa road. 763 km	Grocery/Beer
Highland	Local roads at Fort William A82 to Inverness. 512 km	Timber haulage
NPRA	E6 Fauske - Trondheim. 636 km	Chilled fish
STA	E4, roads 87, 323, 331, 335, 1035 and local roads in Ramsele forest area. 1417 km during spring thaw (very rough). 450 km reproduced in autumn.	Timber haulage

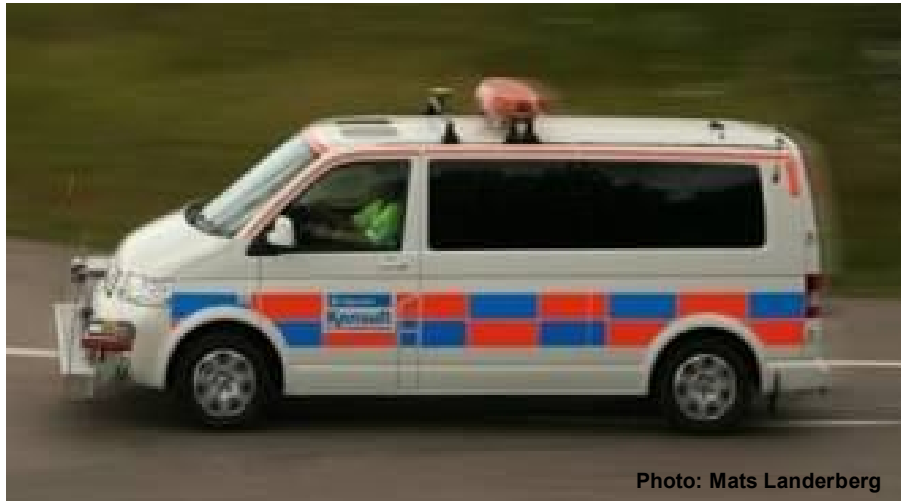
Use high-speed profilometer to identify risk factors

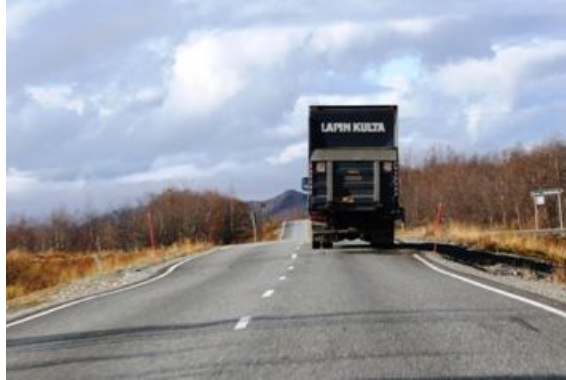
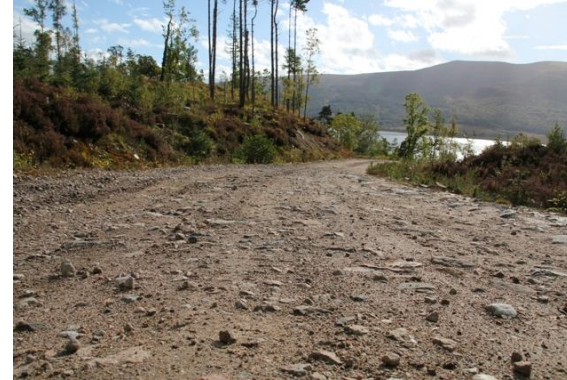
Identifying risks: Ride vibration

***International Roughness Index* detects 0.5 – 30 m waves.**
Note: IRI does NOT measure waves < 0.5 m, ie potholes.
Use *MegaTexture* parameter to detect surface damage such as
ravelling and potholes with waves < 0.5 m.

Dirt roads may be extremely rough and have high variance in stiffness; “soft spots” cause heavy vehicles to bounce.

Corrugation in ice-capped winter roads? Use *truck-mounted accelerometers* to monitor winter roads and dirt roads.

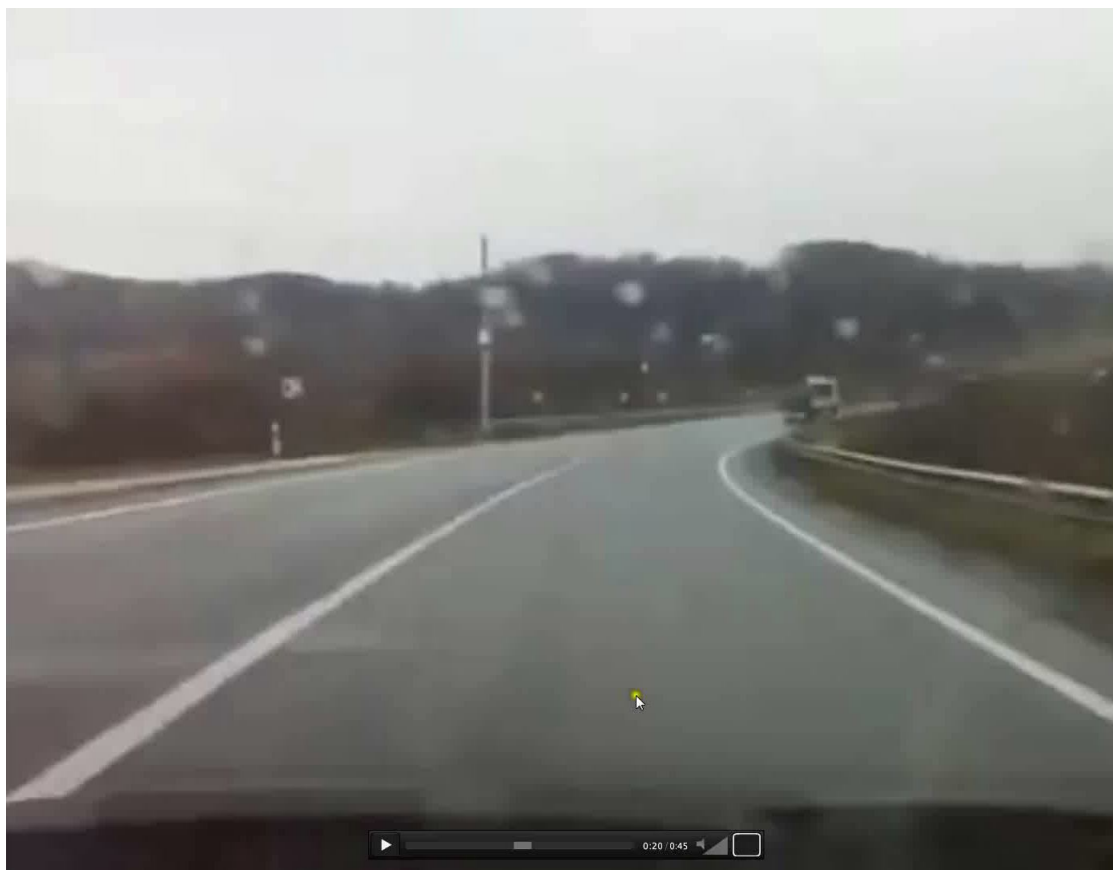
Hydroplaning at banked outer curve

Oncoming Heavy Goods Vehicle brakes at entrance of curve. The waterfilm is very thick just there, due to improperly designed Drainage Gradient (DG).

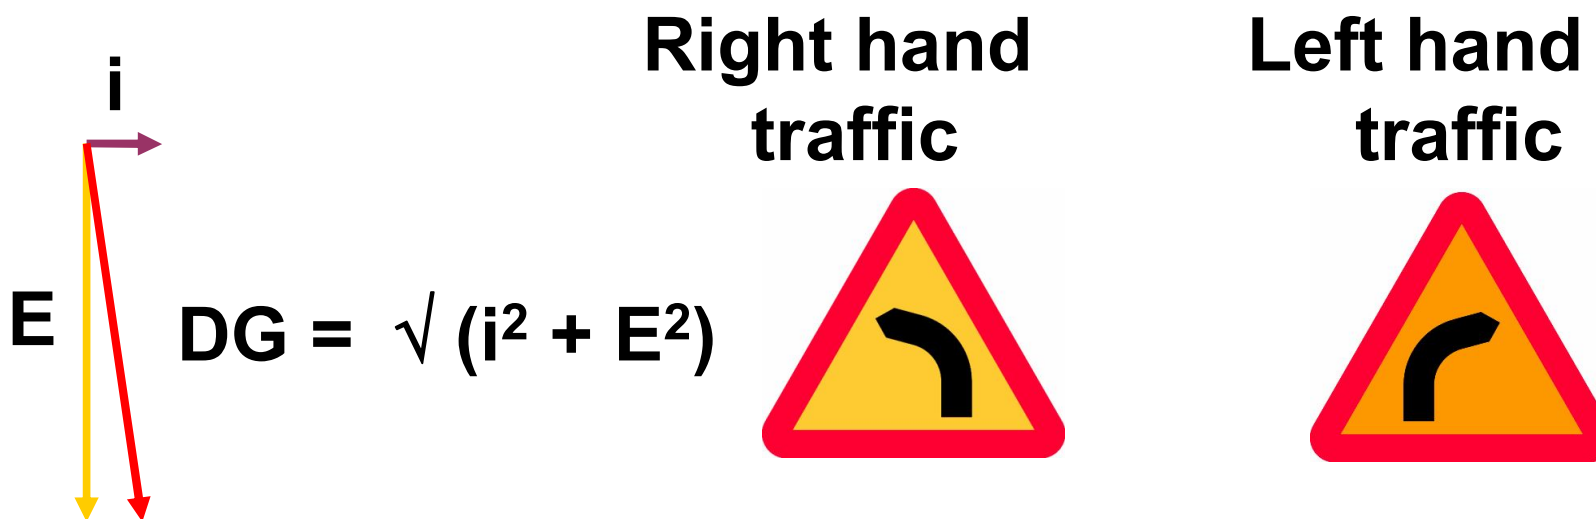
Insufficient drainage gradient (DG)

-Hot spots located at entrance/exit of outercurves.

DG lower than 0.5 % is a key cause to the fact that outer curves show 5 times higher rate in fatal crashes!

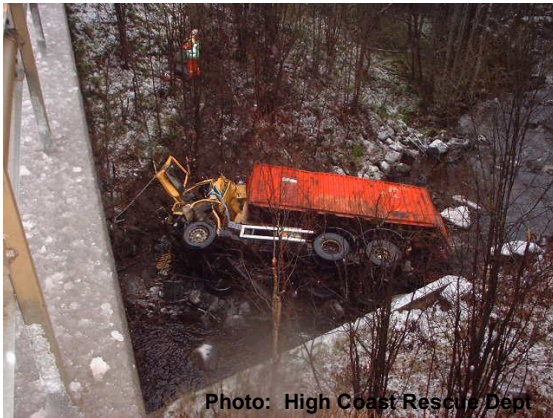
Identifying risks: Hydroplaning

Use road profiler data on crossfall and grade to calculate Drainage Gradient.

Example: 12 risk sections with DG lower than 0.5 % in a 12 km long new road.

All risk sections located at entrance/exit of banked outercurve.

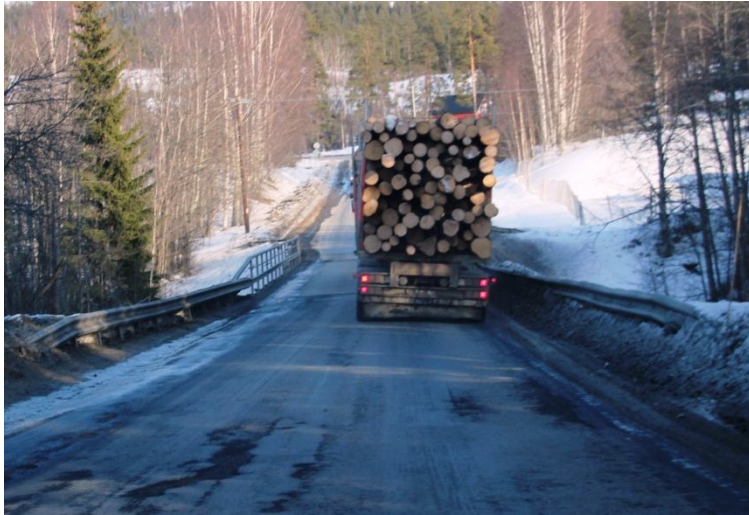
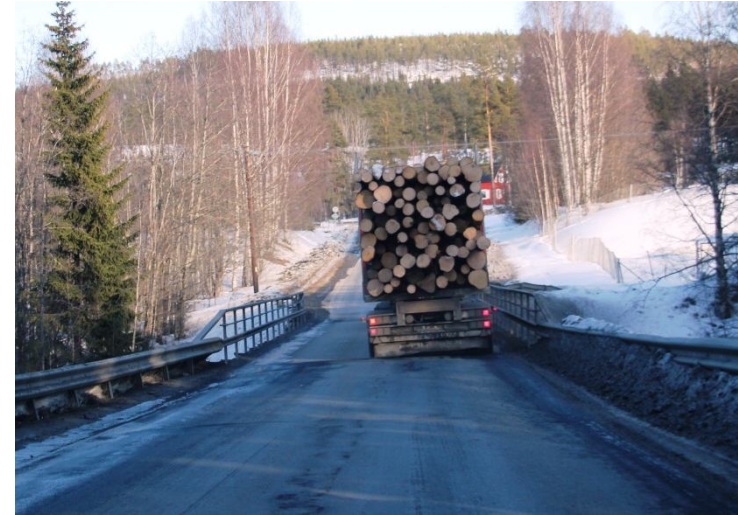
Lateral buffeting

**As a truck rolls, it experience lateral buffeting.
This may trigger a skid crash.
If worser than 5 m/s^2 , cargo latches may break.
A root cause is deformed weak road shoulder.**

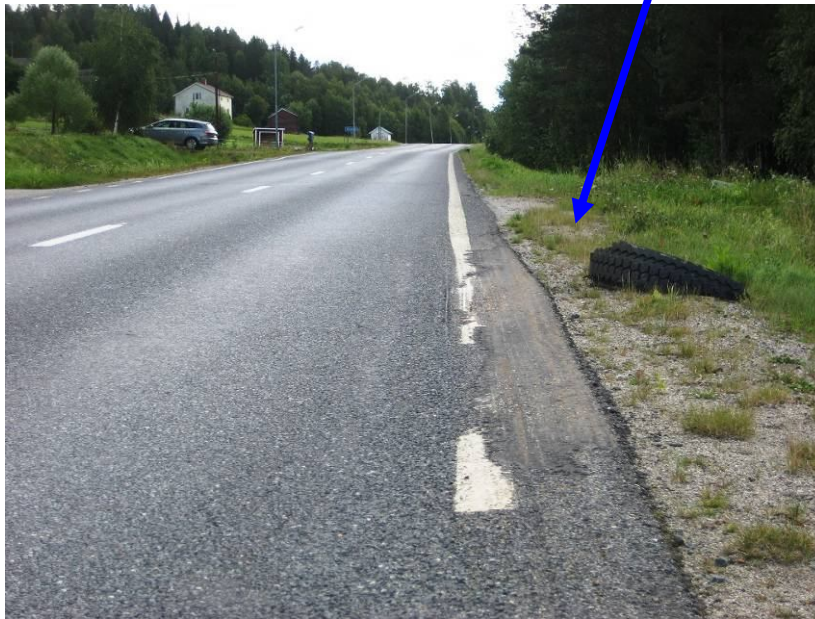
Note: Exploded truck tyre
